AMERAPEX NDT LLC

APPLICATION REPORT

ACOUSTIC EMISSION TESTING OF OIL TANKERS.

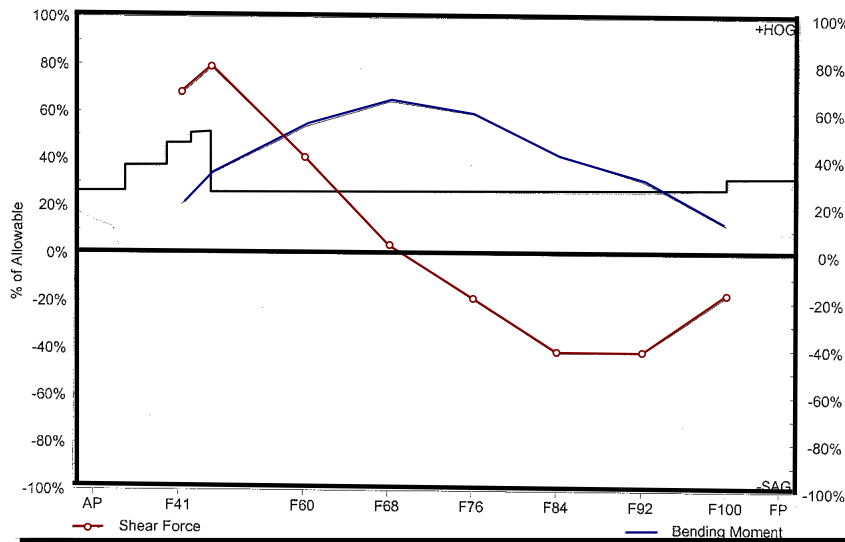
Figure 1. Typical stress distribution during the hogging condition, higher bending Bending moment with lower shear force.

- c. There are two conditions of high stress, when the tanks are empty and the ballast tanks are full this is known as the hogging condition during this the deck is in transverse tension (Port to Starboard) with further longitudinal stresses induced by the Wave action. The second is when the tanks are full and the ballast tanks are empty, the stresses are then transferred to the side walls of the ballast tank area (this application does not address this area, it is planned to conduct this test in the near future)

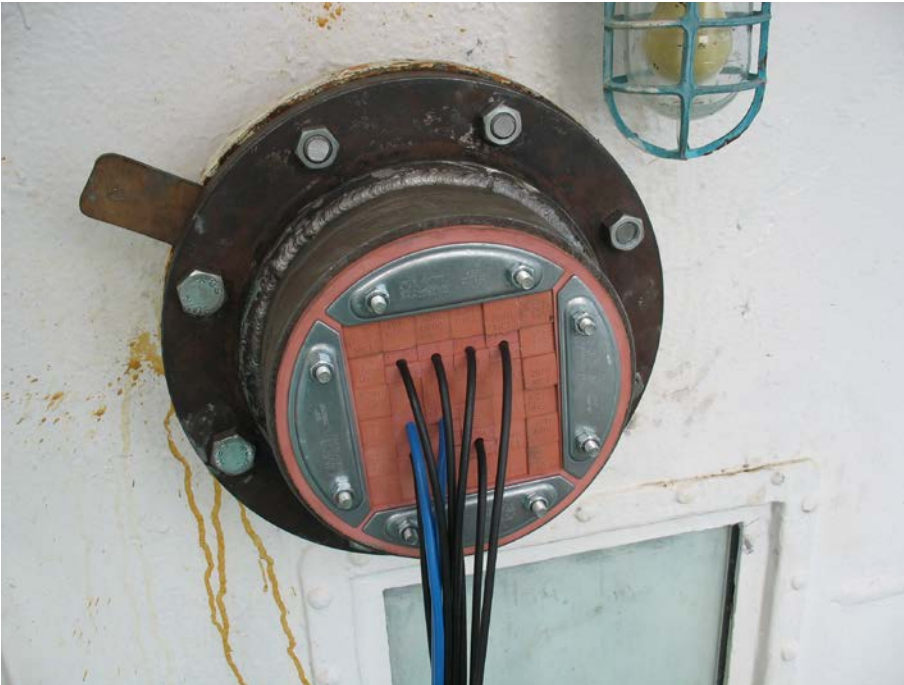
Figure 3. RGP water proof Bulk head entry.

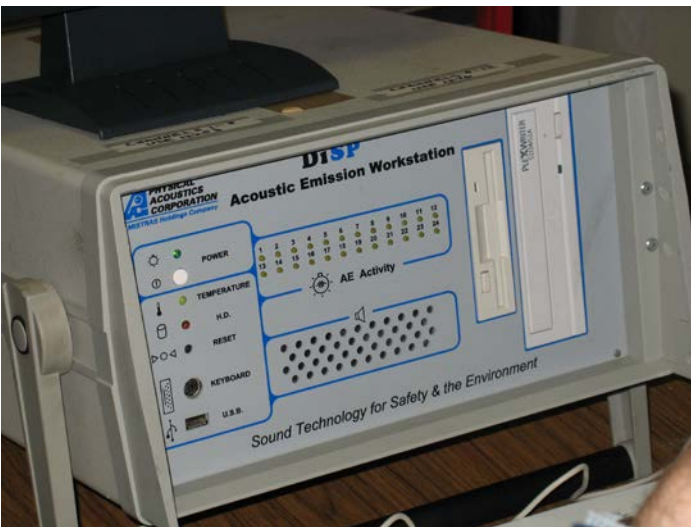
Figure 4. PAC DISP AE work station located in the cargo control room.

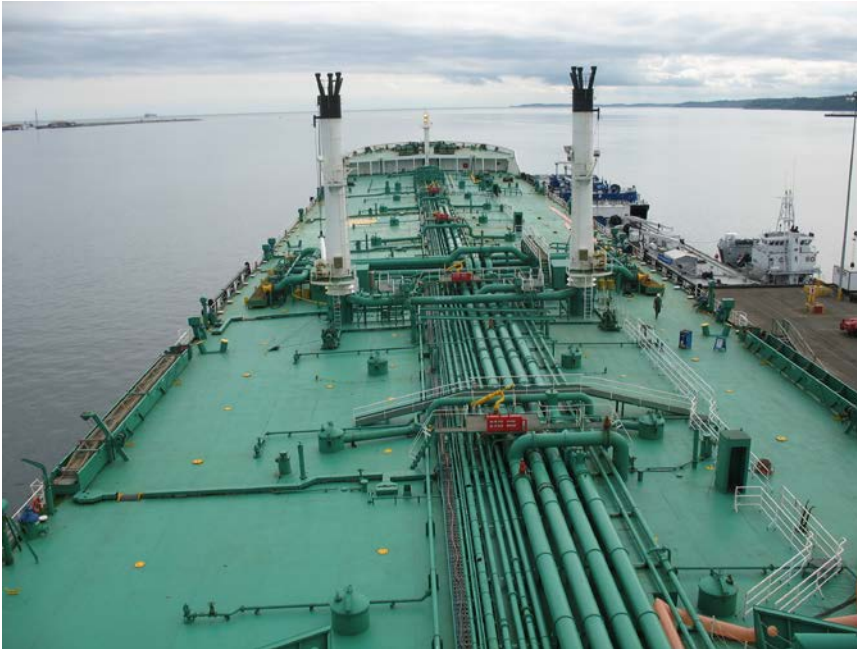
Figure 5. View of the Tanker deck from the control deck. The area of interest is in the center of the picture.

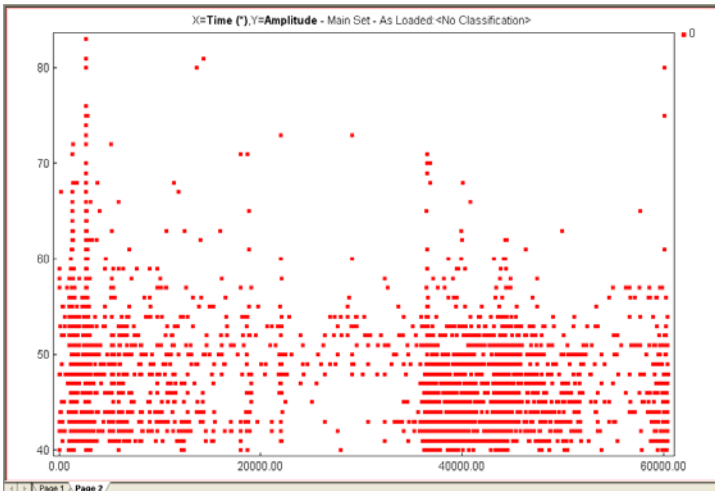
Figure 6. Sample of the raw data before any filtering or signature profiling was done.

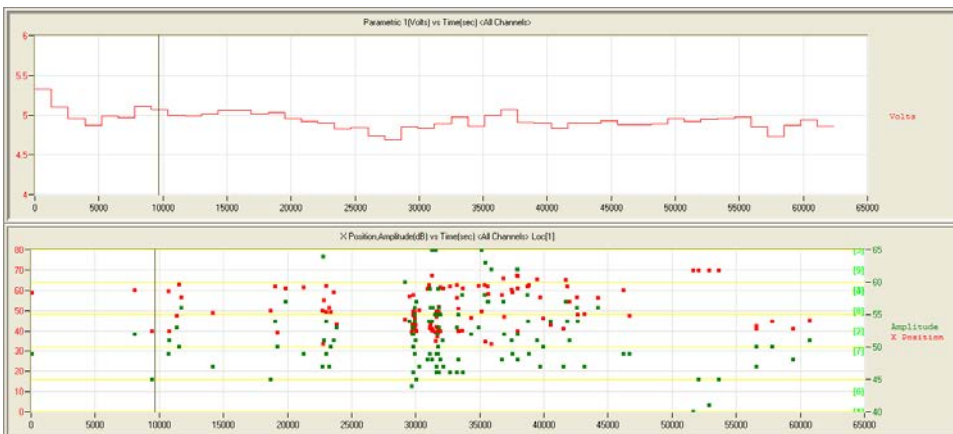
Figure 7. After filtering the data removing activity from rain and mechanical rubbing. The top graph is the recording of the strain gage data and the bottom graph is the AE events recorded, note the increase in events with increase in stress.

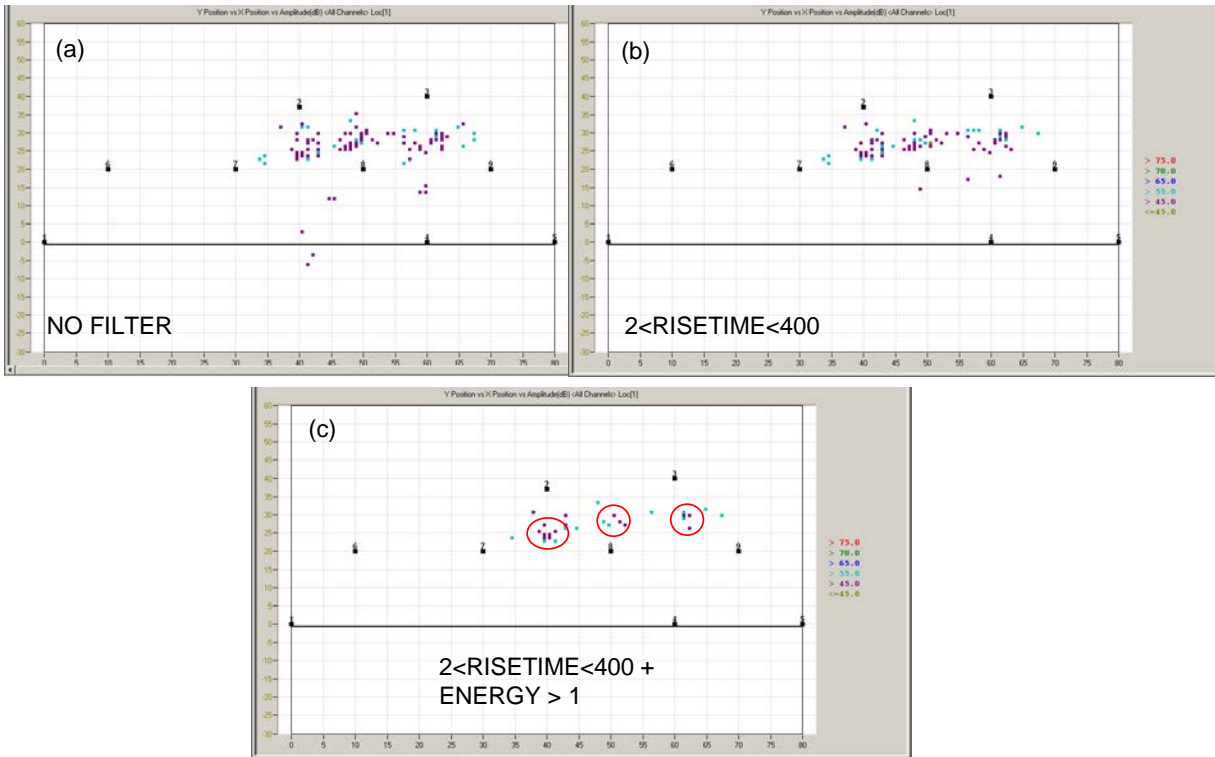
Figure 8. This is the location data of the AE events on the Port side of the Oil Tanker Deck. Note that the first graph top left has not been filtered, the second has a Rise time filter and the bottom graph has both Rise time and Energy filter. All data was filtered using the Noesis program.
