## Sample report overview and rundown.

SAMPLE TANK REPORT (CLIENT NAME)  
OUT-OF-SERVICE API 653 & NDE INSPECTION REPORT  
TANK ###

Out-of-Service API 653 &  
NDE Inspection Report

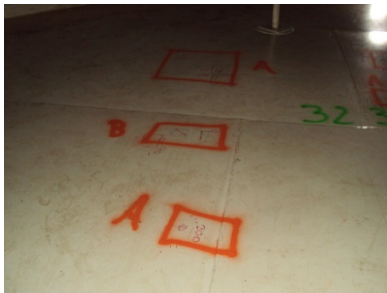
- Results of Bottom MFL scan with repair options based on desired intervals.
- NDE data and evaluation of results for data collected.
- Bottom Edge Projection Ultrasonic Thickness (UTT) Data. One (1) reading every 10 feet from the outside.
- Critical Zone Ultrasonic A-Scan (UTAS) Data; Typically, one (1) every other Survey Station (6 inches X 24 inches). Based on results the scope of work can be modified to include more coverage or the addition of other NDE methods.

- Bottom Layout, Auto-Cad Inspection drawing of the bottom with recordable MFL findings and Visual inspection findings.

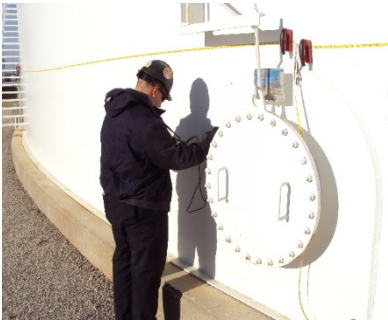
- Outlines the findings of the attachments and appurtenances associated with the shell. These evaluations include documentation of existing details to include dimensional, thickness and comparison to API 650 / 653 requirements.
- Ultrasonic Thickness (UTT) collected at the respective details include. Neck projection(s), four (4) around, 0°, 90°, 180° and 270° and single readings at the flange, cover plates and reinforcement plates as applicable.
- Additional NDE applications can be supported as needed.

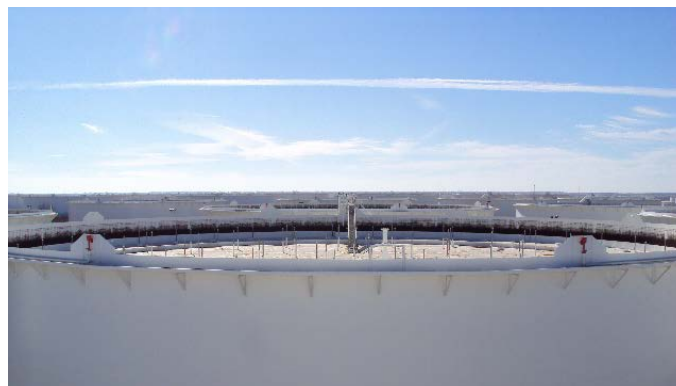
- Outer Rim plate Ultrasonic Thickness (UTT) collected in four (4) quadrants at the top, middle and bottom from inside pontoon compartment. Scope of work can be modified as needed.
- Additional NDE applications can be supported as needed.
- Seal gap data collected when appropriate and documented.
- Rim Space data collected when appropriate and documented.
- Venting capabilities documented.
- Sump(s) Ultrasonic Thickness (UTT) Data and dimensional data.
- Roof drain pipe Ultrasonic Thickness (UTT) data collected based on design.

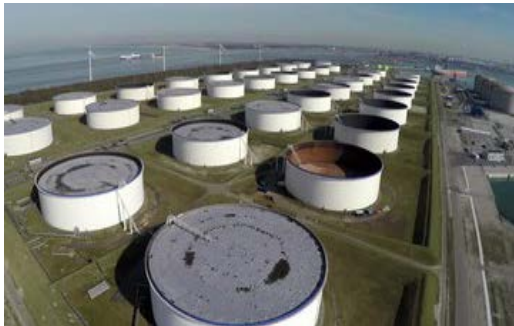
- Outlines the findings of the fixed roof as well as attachments and appurtenances associated with the roof. These evaluations include documentation of existing details to include, thickness and comparison to API 650 / 653 requirements.
- Roof Ultrasonic Thickness (UTT) readings collected at three (3) per plate. Adjustments for more or fewer can be performed.
- Ultrasonic Thickness (UTT) collected at the respective neck details include. One (1) readings at the neck.
- Additional NDE applications can be supported as needed.
- Venting capabilities documented.
- Rafter and column evaluations with aid of aerial platform.
